CARR-1409

Union Mills Savings Bank
Union Mills

Maryland Historical Trust State Historic Sites Inventory Form

Union Mills Savings Bank Moulding Profiles

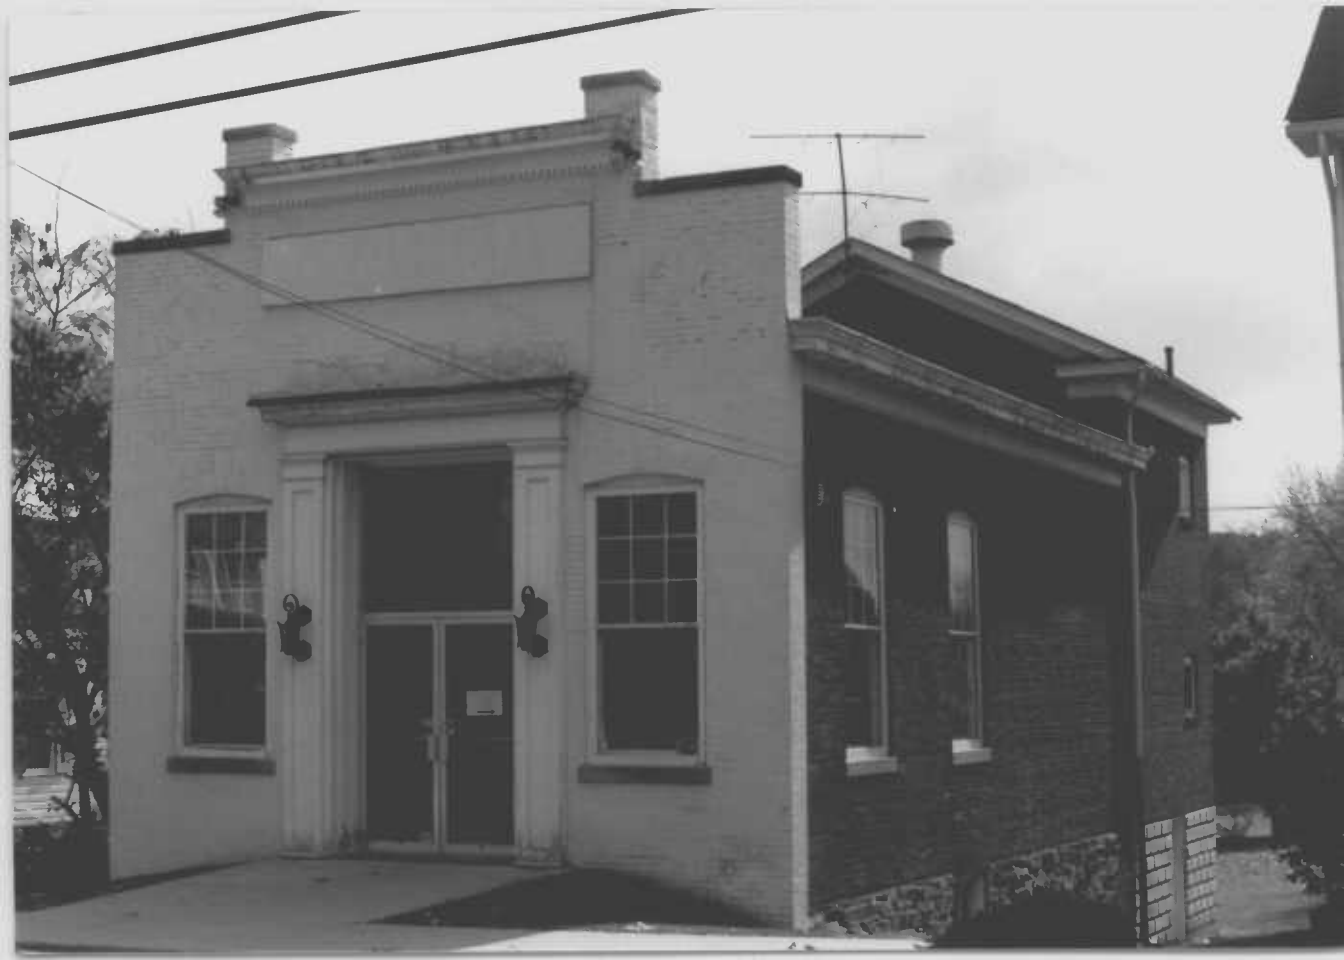
1/4

north & west elevs.

The north elevation has a center entrance with new double doors and transom in an original opening. The door has a stone sill and wood-paneled pilasters with a dentil cornice. There is a wrought and cast iron lantern on each side of the door fastened to the pilaster. The end bays have 9/1 double-hung sash with sills of marble or limestone, bullnose frames, and segmental arches with brick voussoirs and stone keystones. The north elevation has a false front, with a wood dentil cornice at the top of the center bay, flanked by a brick pier that is topped with rock-faced stone. The end bays are lower in height and have rock-faced stone on top with tapestry brick in a diamond pattern just below the stone.

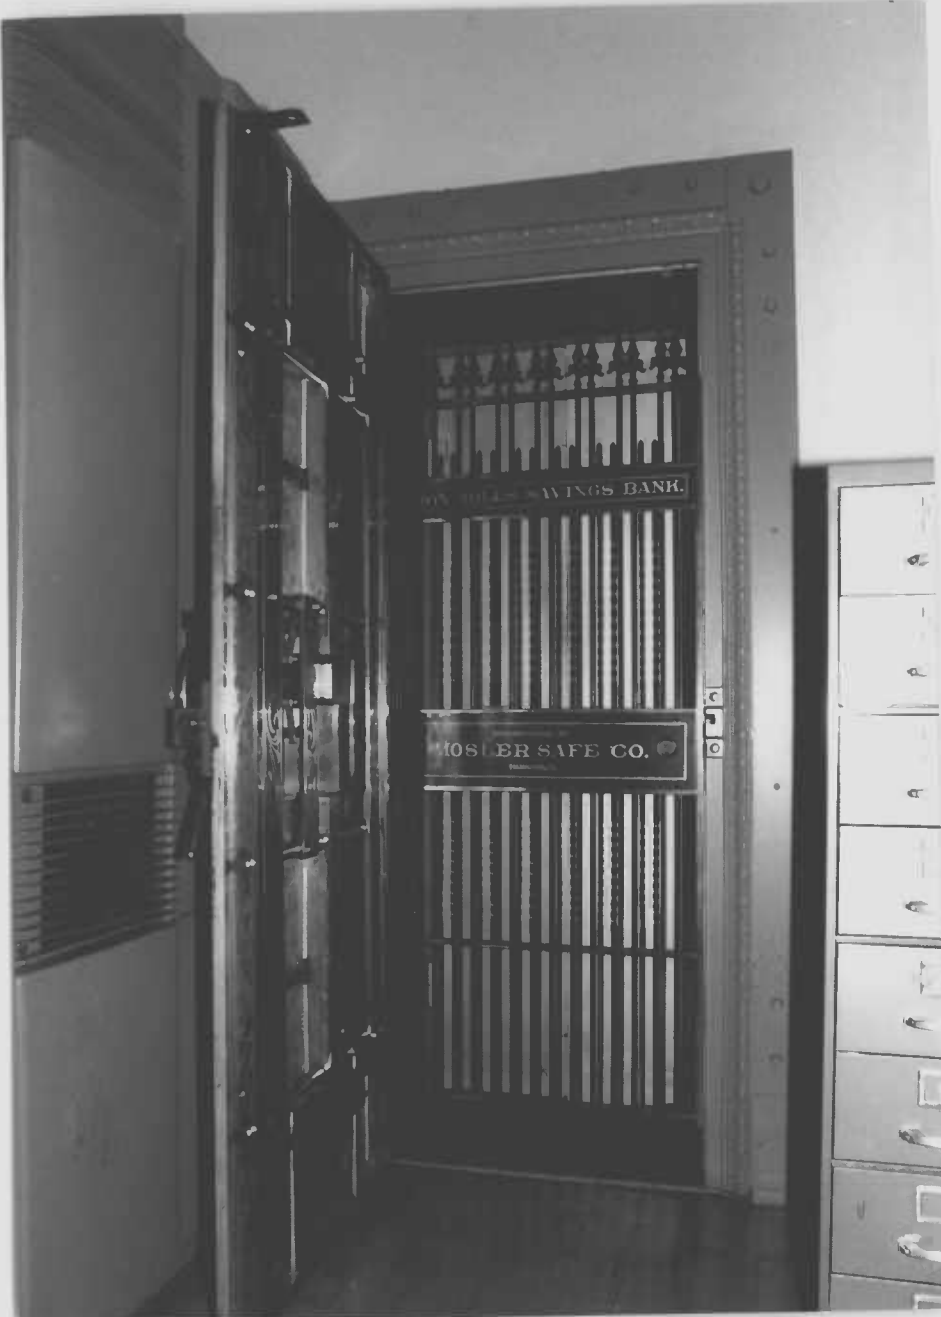
2/4

MOSLER SAFE CO.

Mosler vault

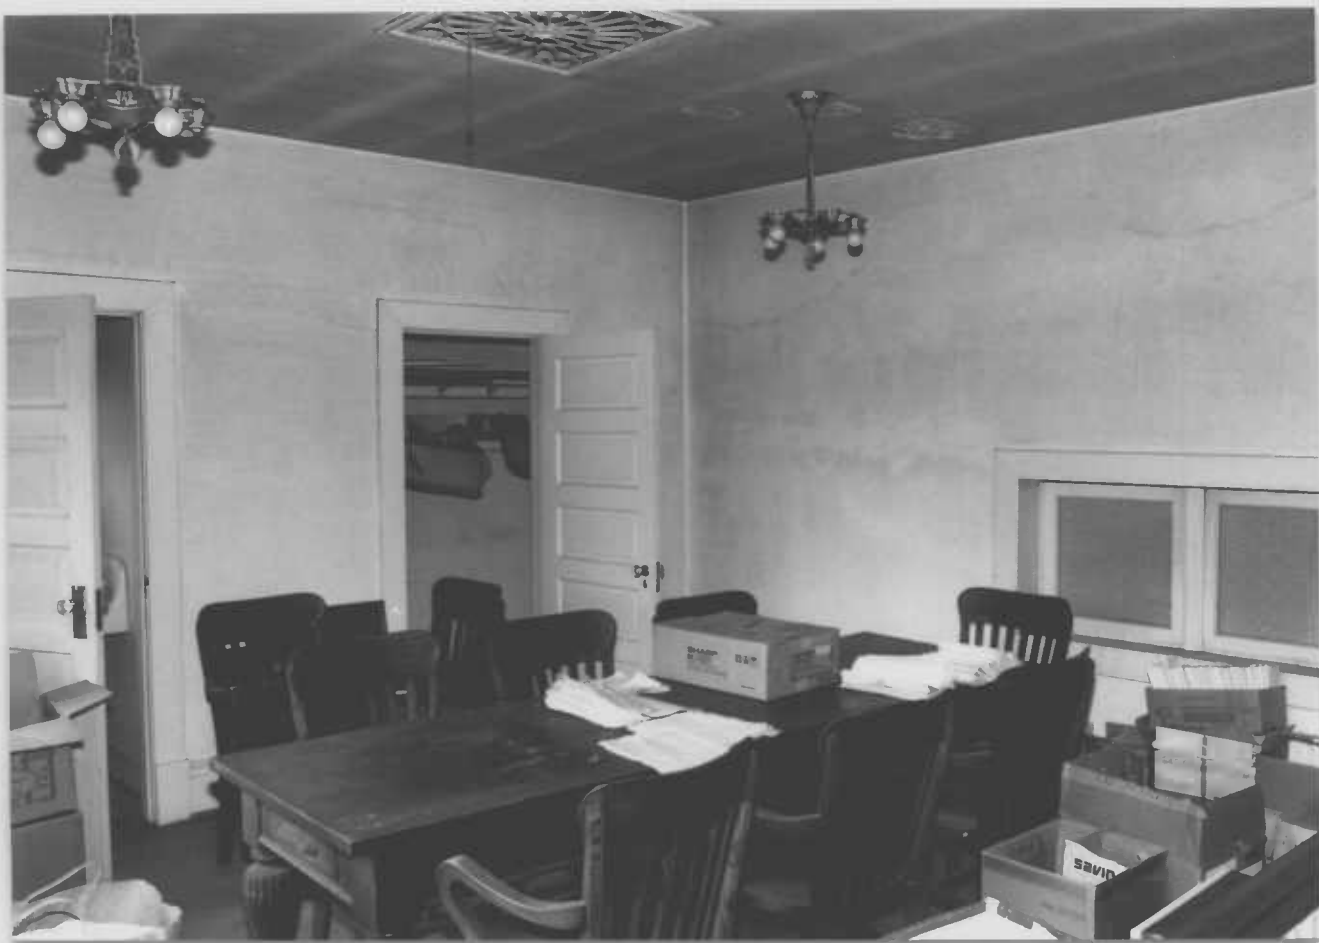
4/4

Bld. of Director's room - view northwest

The second story room has square-in-plan balusters and a moulded handrail around the stair opening. There is 1½-inch-wide oak flooring that runs north-south. The northeast corner has a closet set over the stairs. It has a typical five-panel door. The north wall has two one-light casements that used to look down on the banking room, but are now closed off because of the drop ceiling in the banking room on the first story. The plan is laid out like the first story south room with a closet and bathroom on the west elevation that have typical five-panel doors. The sink is the same as on the first story. The toilet is marked "Standard", and the date stamped on it is "Jan. [25?] 1927". The room has an oak table with a bead and reel around the bottom edge and turned reeded legs. There is a drawer in each end of the table, and there are nine oak arm chairs. Two cast bronze lamps hang from the ceiling, and in-between them is a metal grate in the ceiling for ventilation.
